Application Case Study

Shipping Rack: Truck Bumper Rack - Dunnage

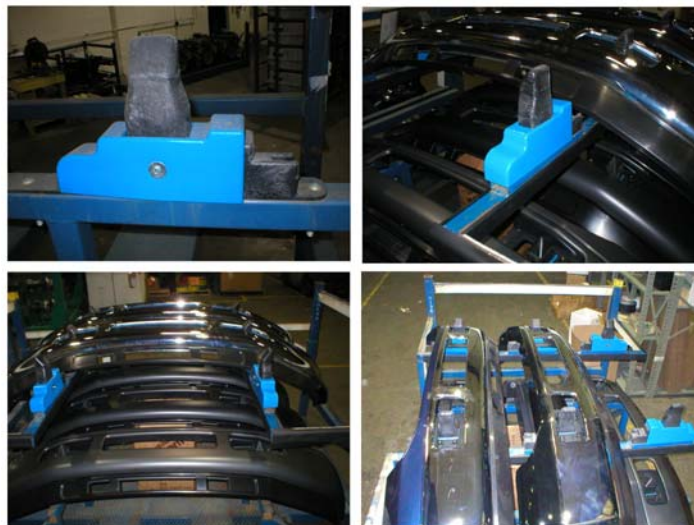
The blue boot was developed to fit the contour of the bumper frame of the current bumper and of the new bumper. Instead of having two separate nesting posts, PFP engineers designed one boot to accommodate both bumpers. The material is a vibration dampening thermoset urethane. The boots reduce the vibration and movement of the bumpers and eliminated the problem of the bumper becoming dislodged. The slip-on boot design allowed for easy installation and reduced the overall cost of the rack conversion.

The shipping container is comprised of a steel rack frame with plastic nesting posts. Truck bumpers are loaded into the rack and seated over the black plastic posts. The bumpers are unrestrained in the rack. The bumpers are shipped by truck and by rail from the bumper manufacturer to several assembly plants.

During truck and rail shipments, the bumpers were climbing off of the nesting post and becoming dislodged from the rack. The dislodged bumpers were scratched or damaged and often collided with other bumpers in the rack. The loose bumpers complicated the unloading of truck and railcar shipments. The rack is due to be retrofit in order to accommodate a new bumper design. All bumper nest posts would be removed during the rack conversion and new posts replaced.
